EVALUATION OF THE AQUA WRAP SYSTEM IN REPAIRING MECHANICALLY- DAMAGED PIPES

PN114315CRA

**Prepared for
AIR LOGISTICS, INC.
Azusa, California**

**September 2005
Revision 1**

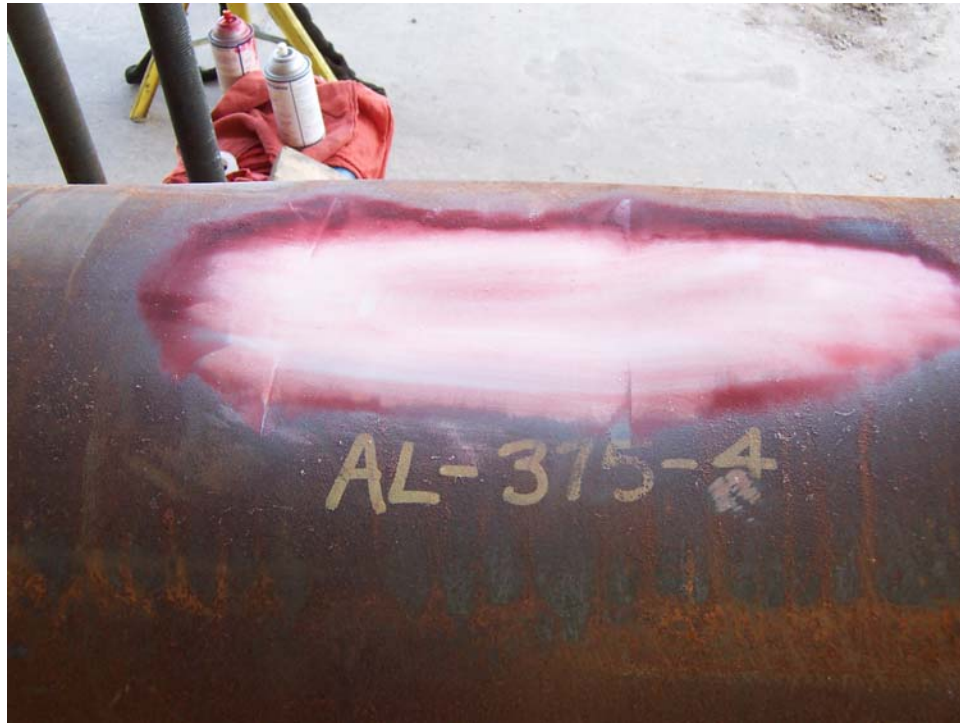
Figure 3 - Dye penetrant used to ensure gouge removal by grinding

- [1] Remove the gouge by grinding with a hand-held grinder. Dye penetrant was used to ensure that the crack was completely removed. Measure the remaining wall thickness. **Figure 3** shows the application of dye penetrant to the damaged region and **Figure 4** shows one of the samples polished in its final state before installation of the repair material.

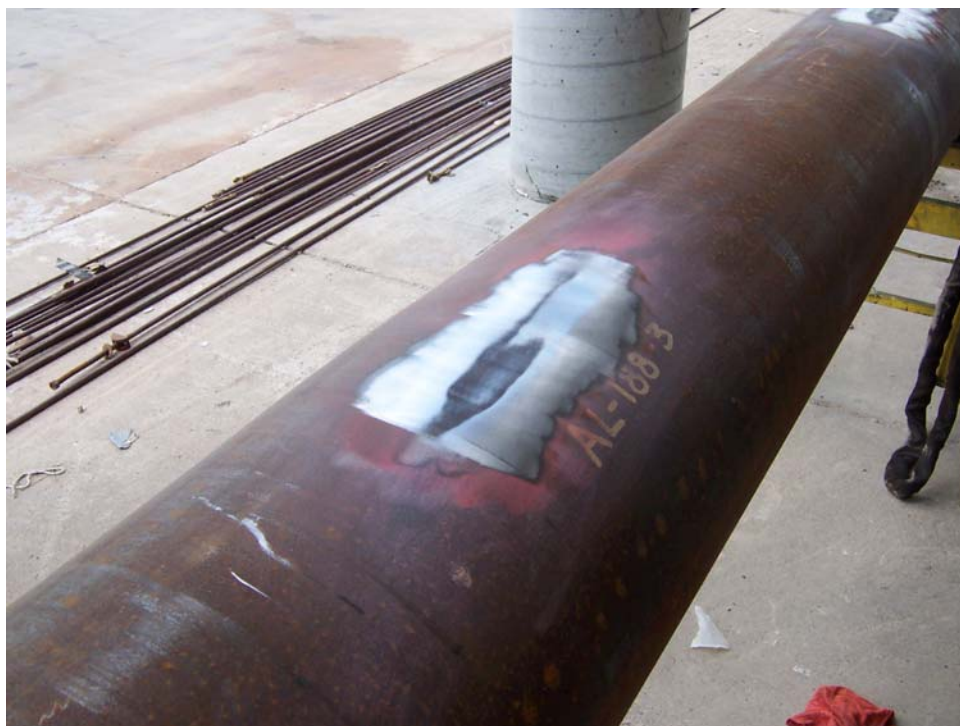
Figure 4 - Gouge removed by grinding

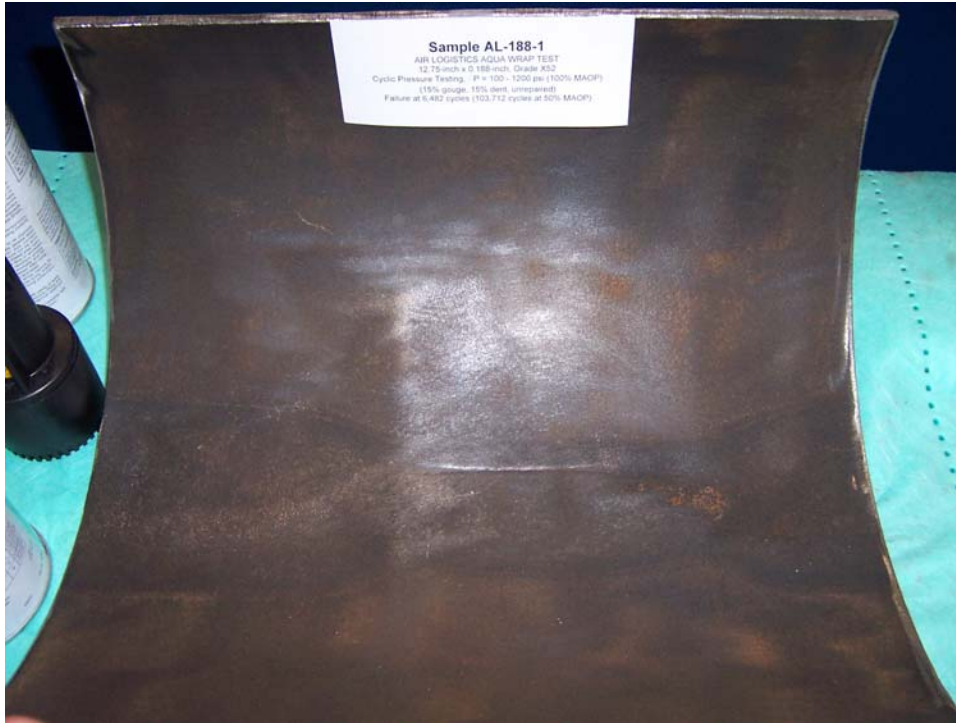
Figures 11, 12, 13, and 14 show failures for samples AL-188-1, AL-118-2, AL-375-1, and AL-375-2, respectively. The key point to note is the radial deformation that occurs in the unrepaired defects (AL-188-1 and AL-375-1). The extensive deformation associated with the unrepaired defects confirms that the filler material must have a sufficient level of rigidity to prevent the radial deformation due to internal pressure.

Figure 11 - Post-failure photo of Sample AL-188-1

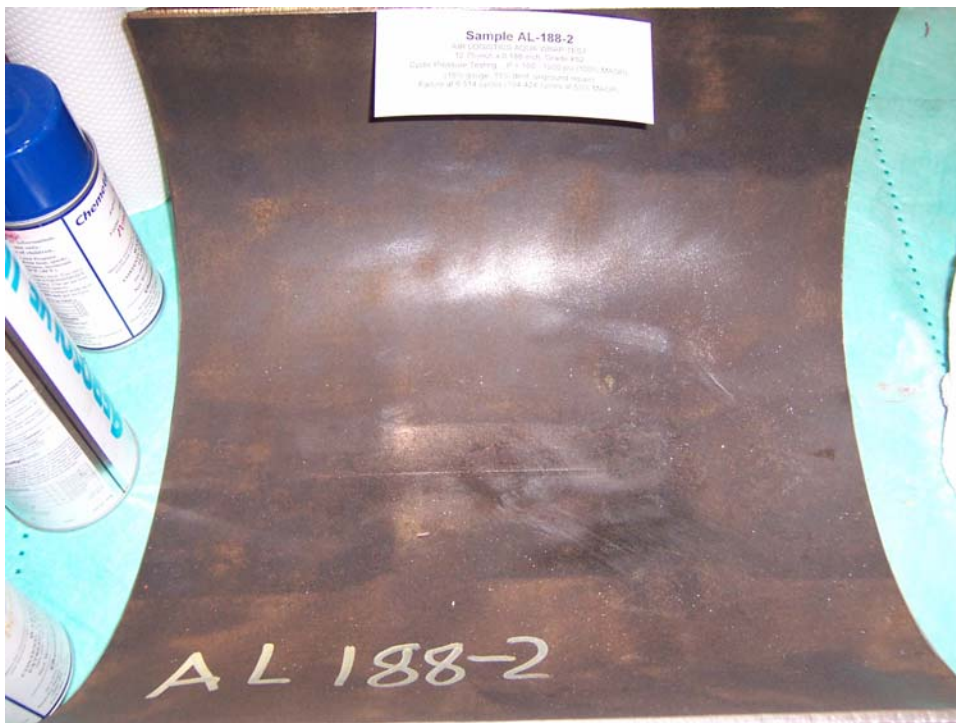
Figure 12 - Post-failure photo of Sample AL-188-2

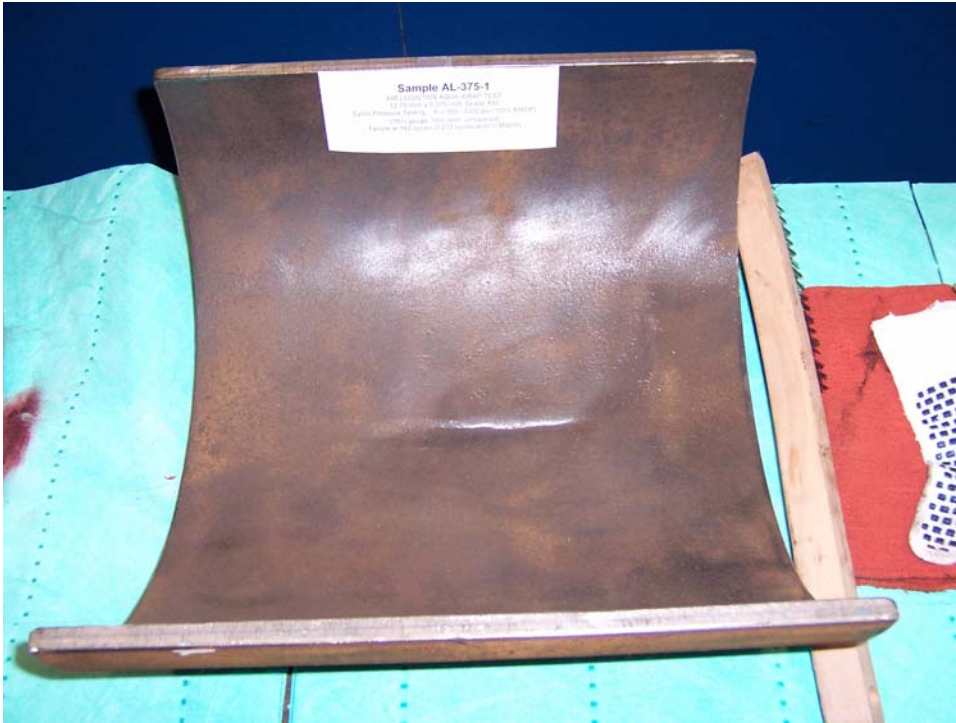
Figure 13 - Post-failure photo of Sample AL-375-1

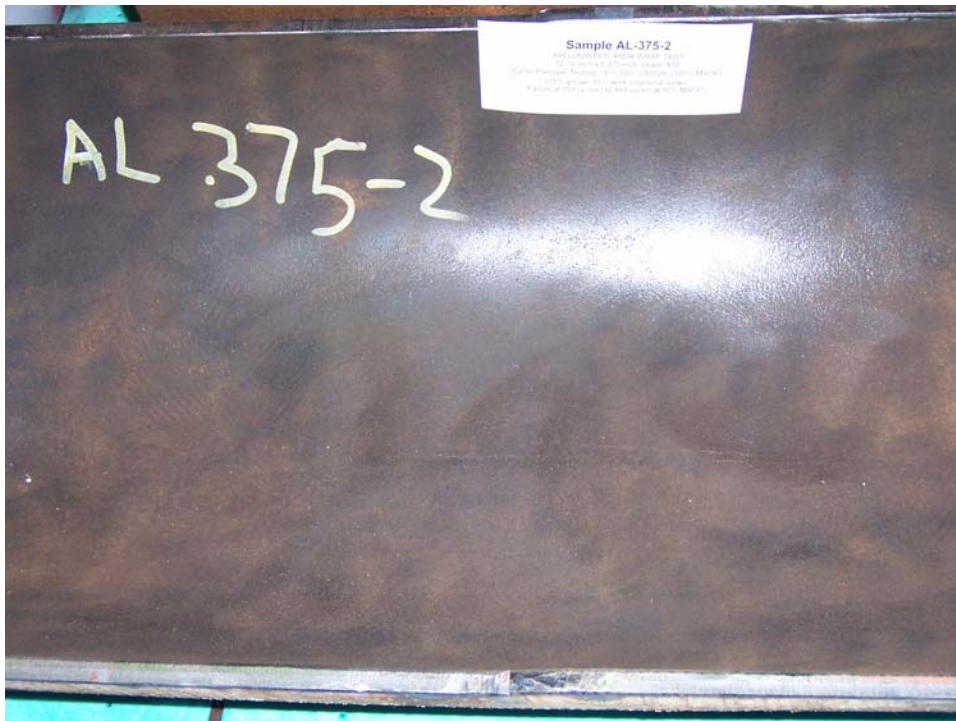
Figure 14 - Post-failure photo of Sample AL-375-2
