# **Testing of Aquawrap<sup>®</sup> for use in Repairing Damaged Pipelines**

## **Burst Testing Pursuant to ASME PCC-2**

Prepared By  
Franz Worth, PE

March 31, 2008

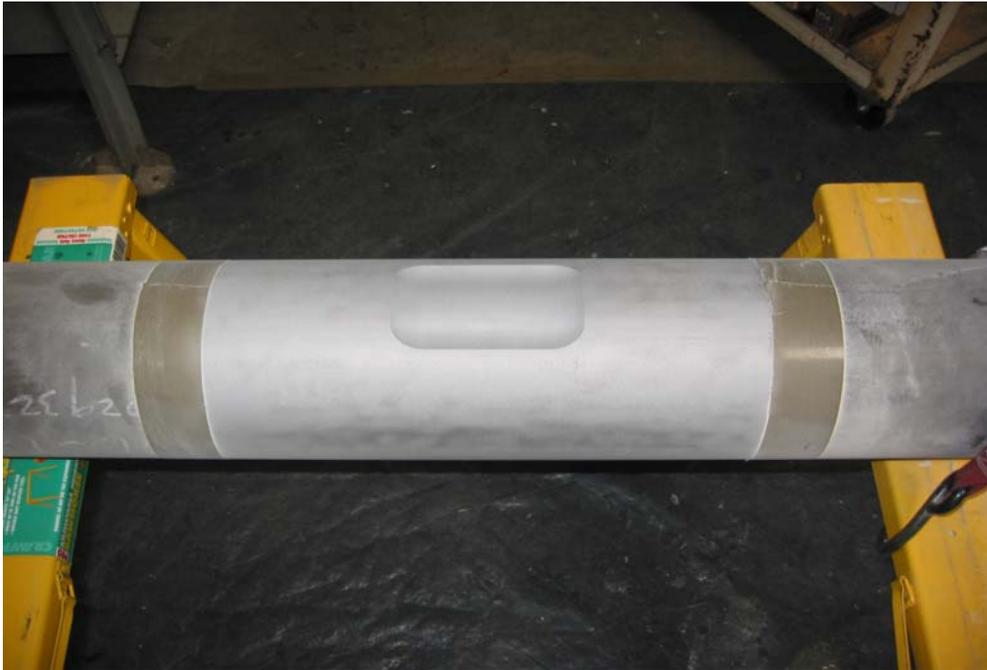
The pipe section selected for the test was 6” nominal diameter X42. The actual tensile strength of the steel was 48074 psi. The wall loss in the machined defect area was 80%. The defect was 6.625” long by 3.125” wide. The repair material used was tested separately and had a per ply strength of 706 pounds per inch of width. The test pressure was calculated at 6270 psi and the number of layers of wrap at 24.

Photo 1. Machined Pipe

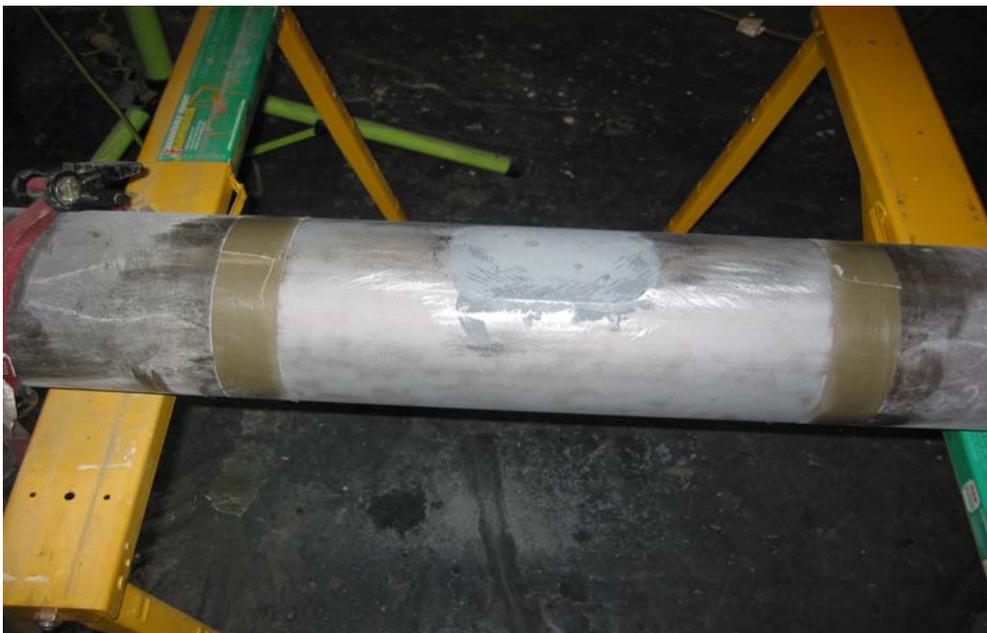
Photo 2. Pipe with load transfer material installed

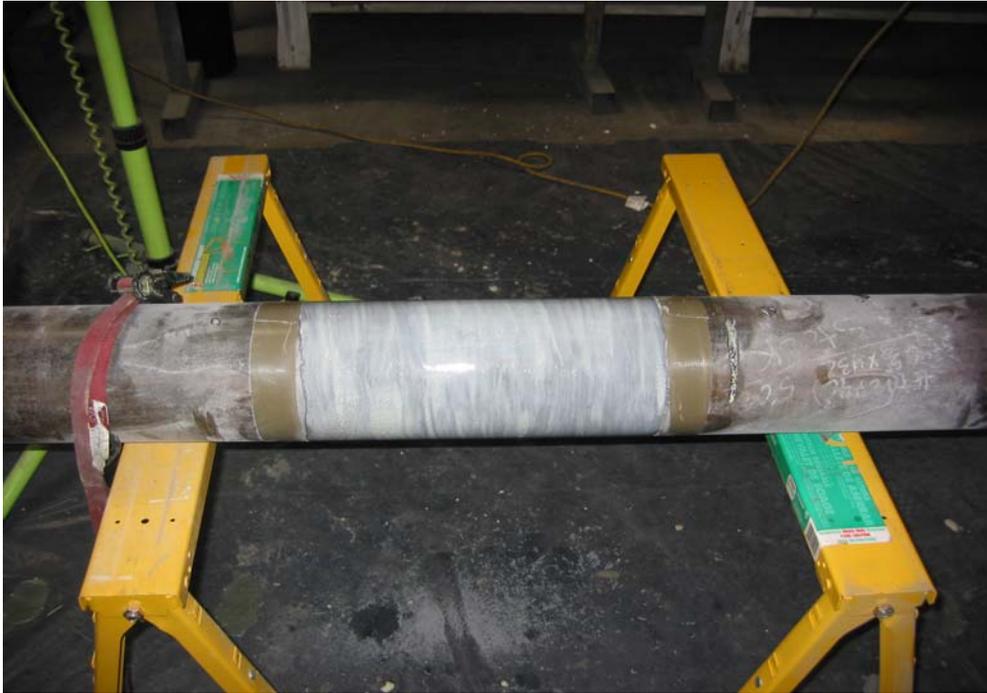
Photo 3. Pipe with adhesive

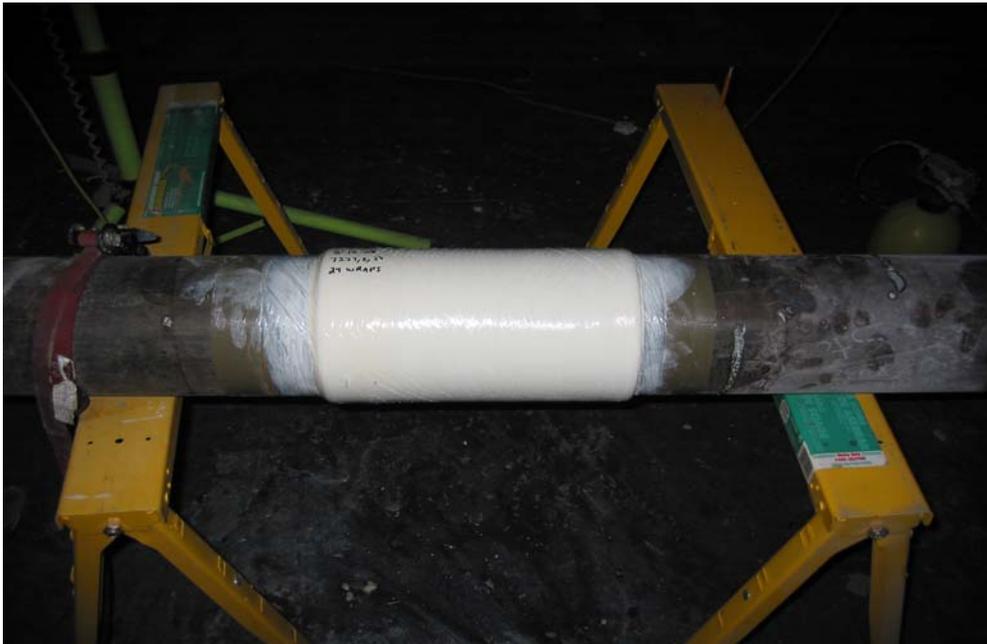
Photo 4. Pipe with wrap installed

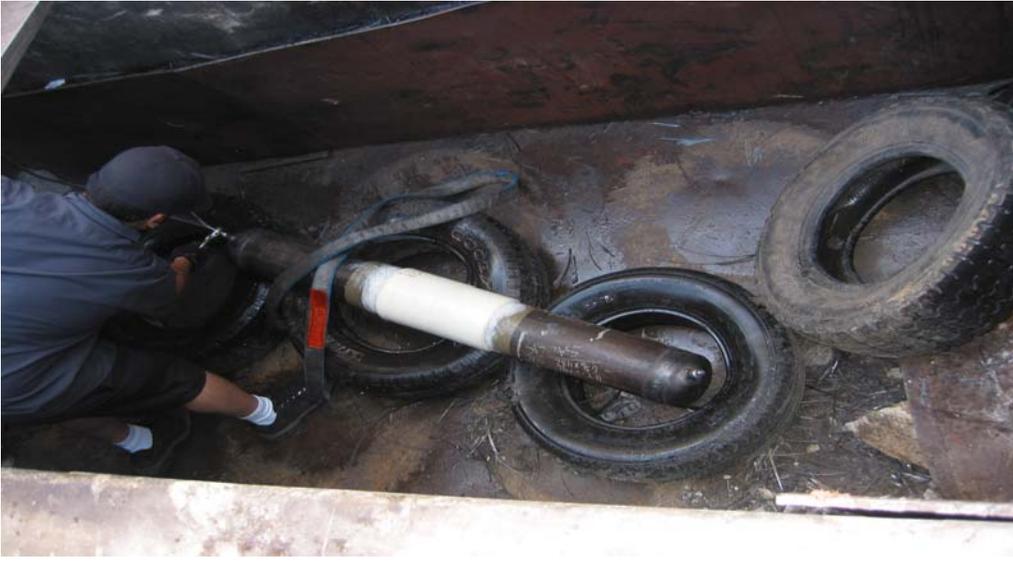
Photo 5. Wrapped pipe in test pit.

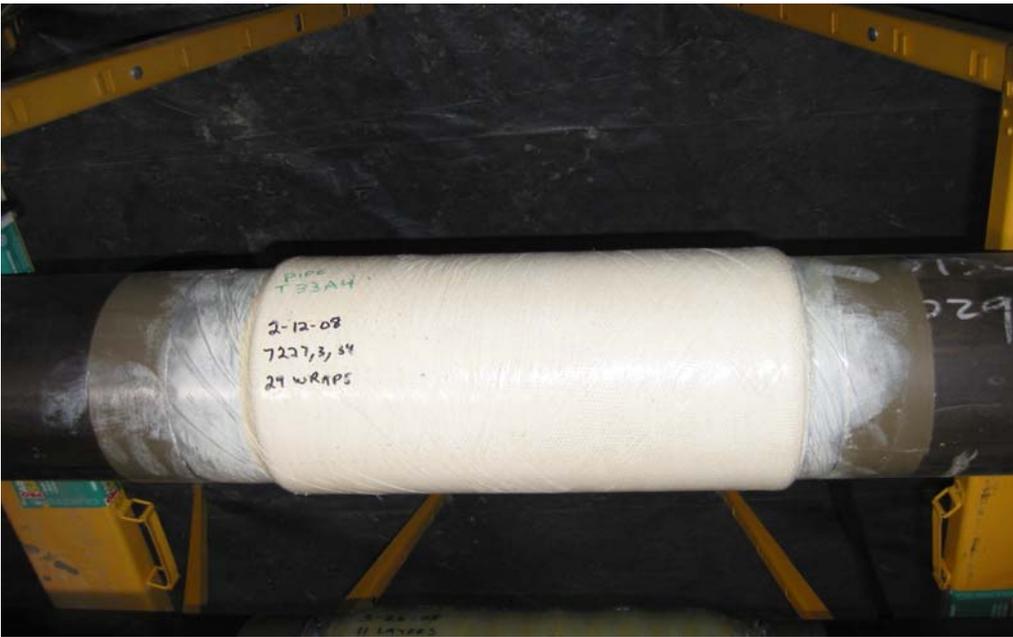
The repaired pipe section was taken to Authorized Testing where the test was performed. The pipe section was placed in a pit and the testing commenced. The pipe was pressurized to 6900 psi and the pressure was released. There were no signs of wrap failure or leaks. This result is very good in as much as the pipe withstood about 10% greater pressure than required and did not fail.

Photo 6. Pipe section after successful test.
