Testing of Powersleeve[®] for use in Repairing Damaged Pipelines

Burst Testing Pursuant to ASME PCC-2

Prepared By
Franz Worth, PE

March 31, 2008

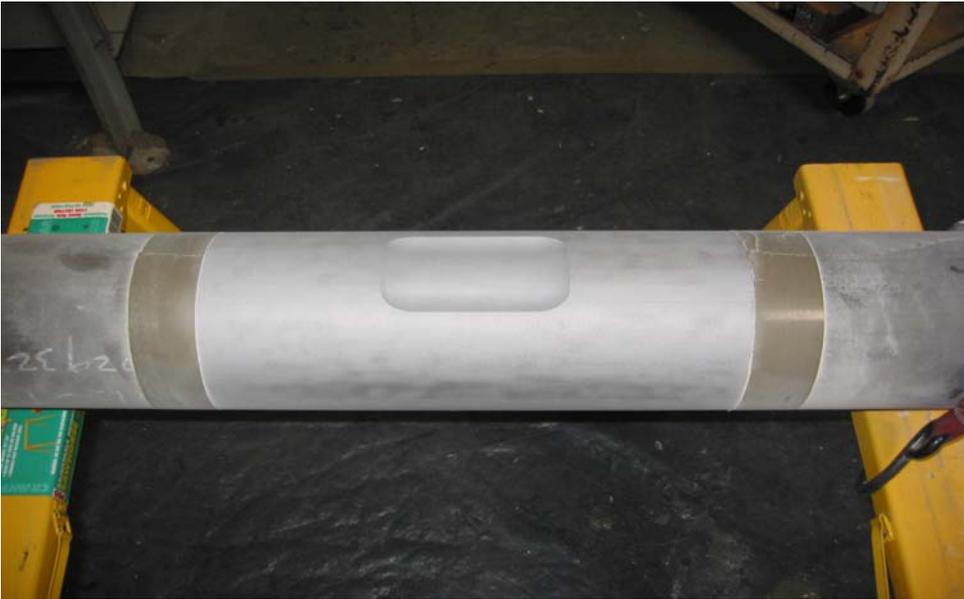
The pipe section selected for the test was 6” nominal diameter X42. The actual tensile strength of the steel was 60,730 psi. The wall loss in the machined defect area was 80%. The defect was 6.625” long by 3.125” wide. The repair material used was tested separately and had a per ply strength of 1970 pounds per inch of width. The test pressure was calculated at 7920 psi and the number of layers of wrap at 11.

Photo 1. Machined pipe.

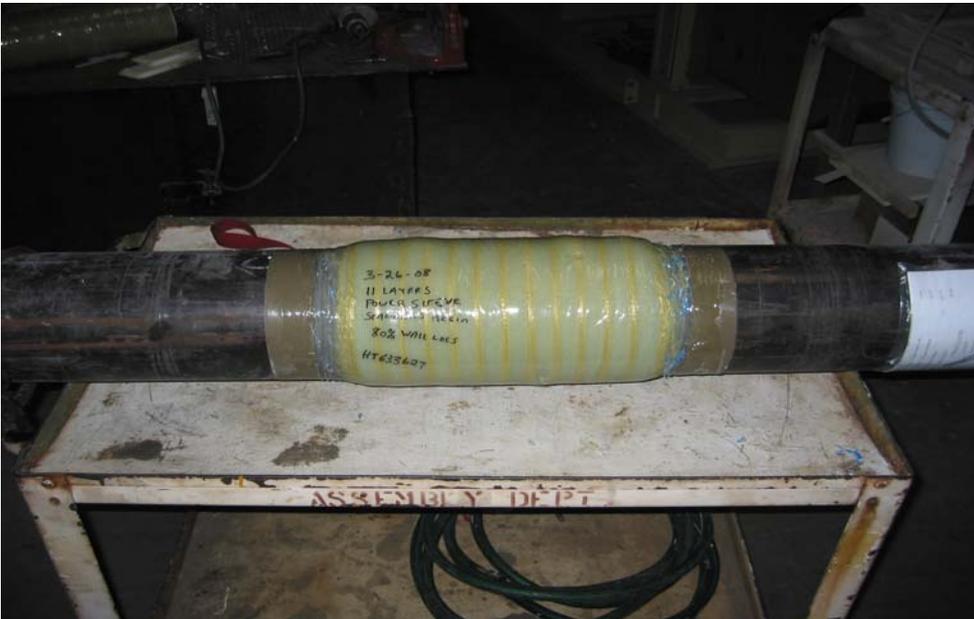
Photo 2. Pipe with Powersleeve™ installed.

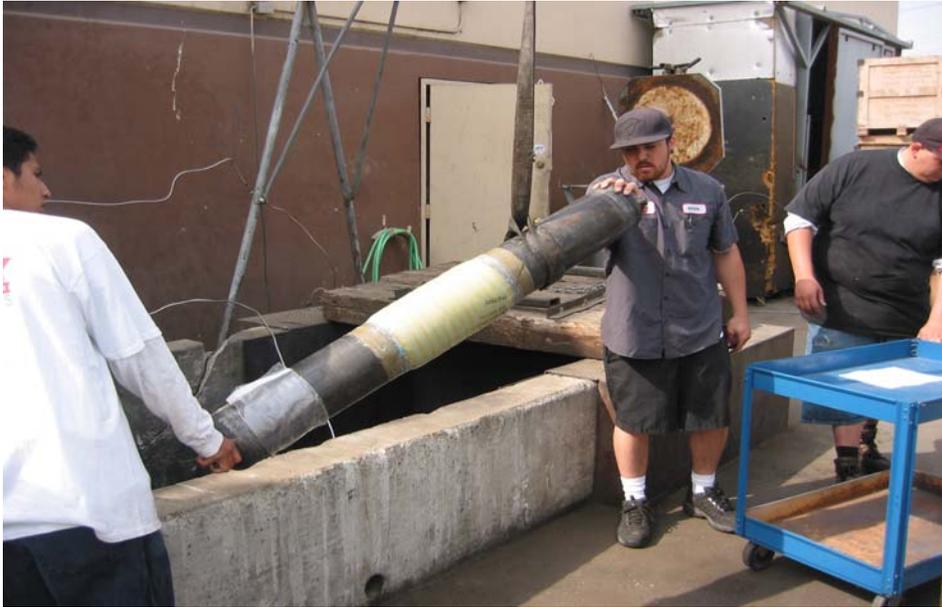
Photo 3. Wrapped pipe being lowered into test pit.

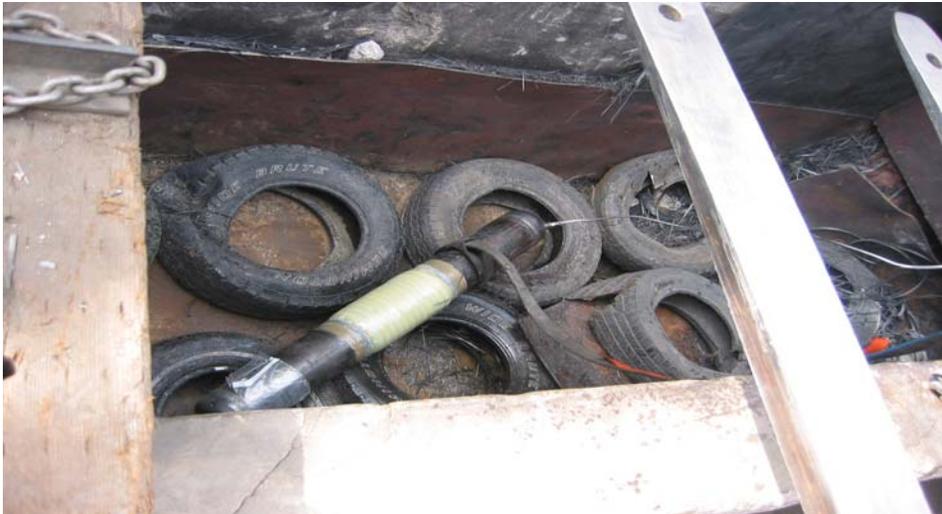
Photo 4. Pipe in test pit.

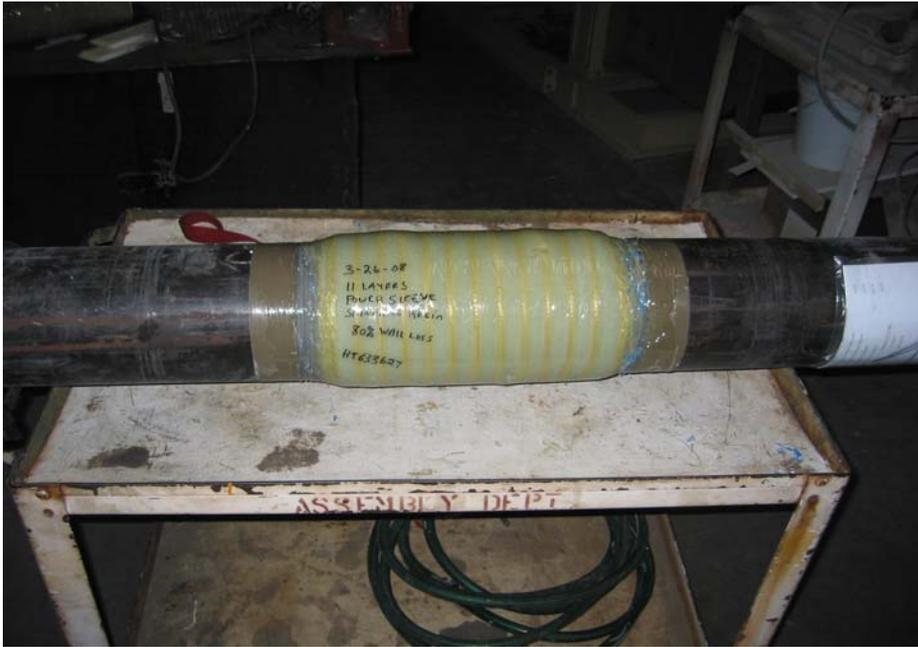
The repaired pipe section was taken to Authorized Testing where the test was performed. The pipe section was placed in a pit and the testing commenced. The pipe was pressurized to 8200 psi and the pressure was released. There were no signs of wrap failure or leaks. This result is very good in as much as the pipe withstood a greater pressure than required and did not fail.

Photo 5. Pipe section after successful test.
