EVALUATION OF THE AQUA WRAP SYSTEM IN REPAIRING MECHANICALLY- DAMAGED PIPES

PN114315CRA

**Prepared for
AIR LOGISTICS, INC.
Azusa, California**

**September 2005
Revision 1**

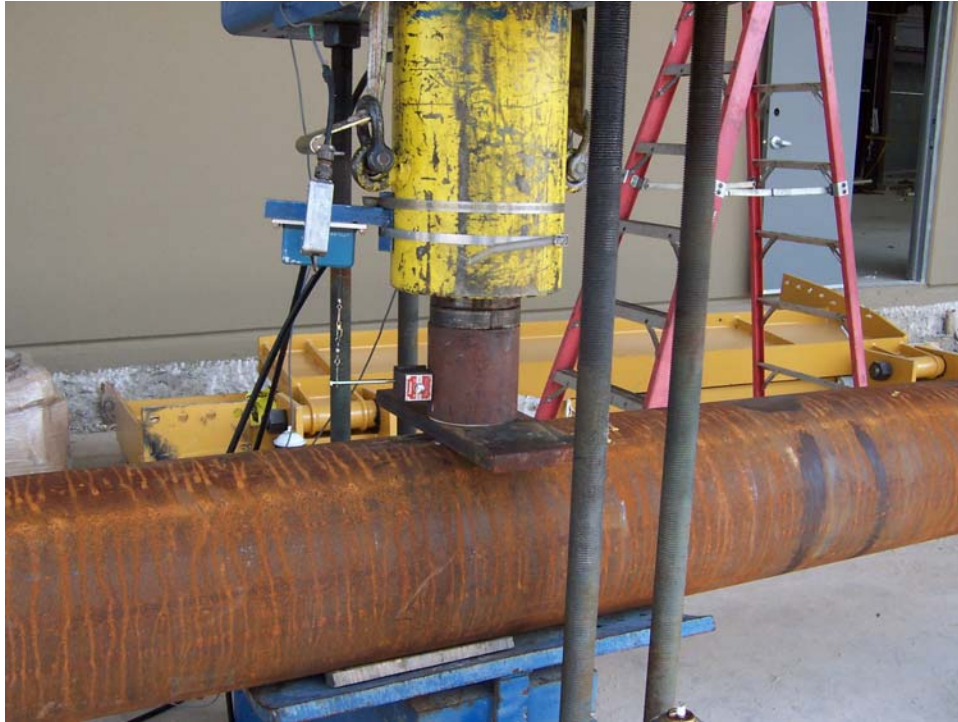
Figure 1 - Dent installation rig to install dents

- [3] Install dents in the pipe using a 6-inch wide plate. The initial indentation depth will be 15 percent of the pipes outer diameter and the indenter plate. Four dents will be installed in each 20-ft long pipe samples. Each dent will be offset 2 inches longitudinally from the respective gouge, resulting in a total defect length of 8 inches. **Figure 1** shows the dent installation rig.

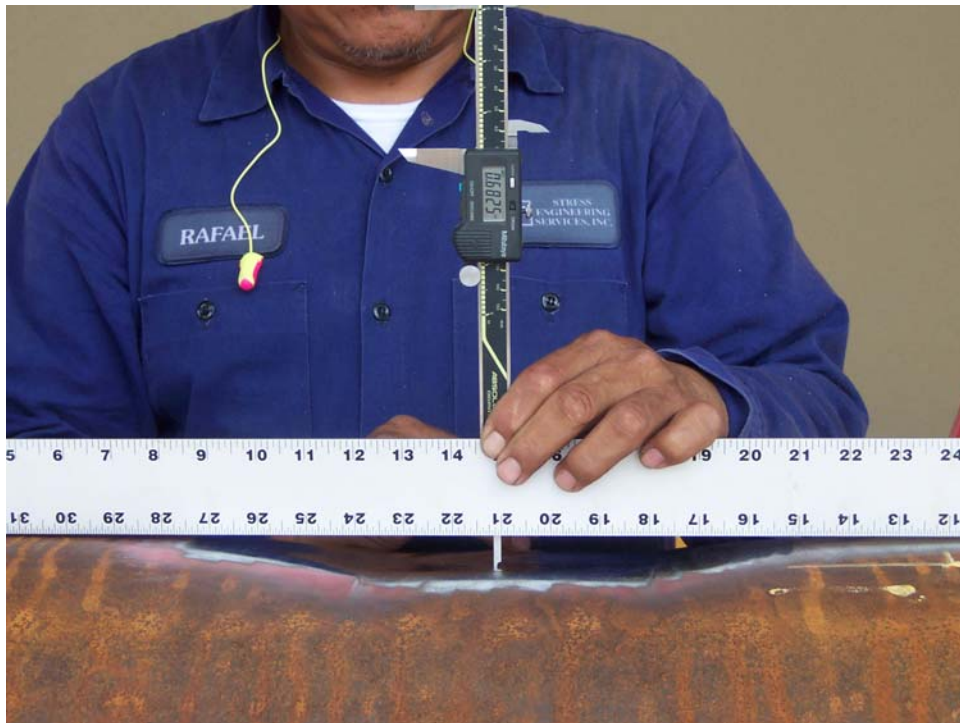
Figure 2 - Measuring dent depth and profile

- [4] Allow each dent to reround elastically with removal of the indenter and measure the longitudinal profile (side view of dent and process shown in **Figure 2**).

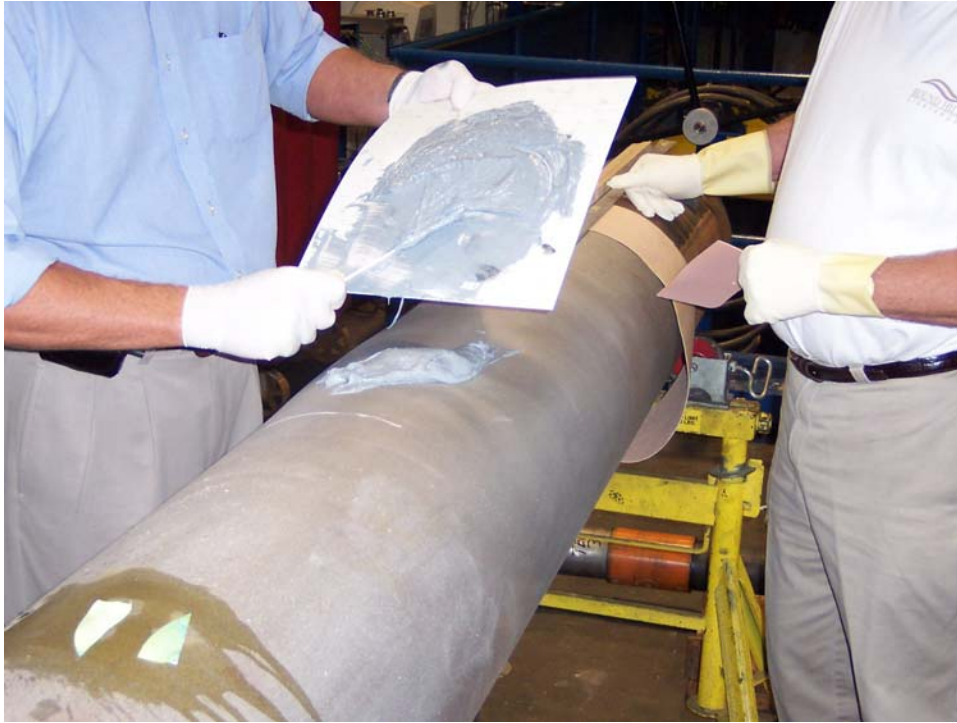
Figure 5 - Epoxy material used to fill the dented region

Figures 5 through **8** are photographs taken during the installation of Aqua Wrap on the damaged sections of the test pipes.

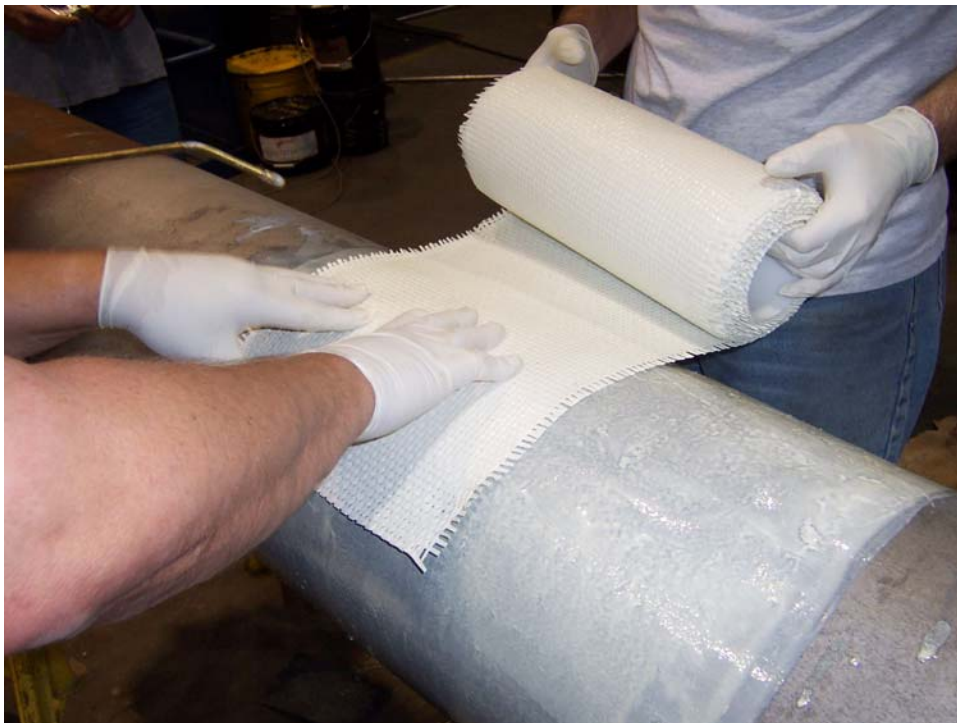
Figure 6 - First layer of Aqua Wrap installed on pipe

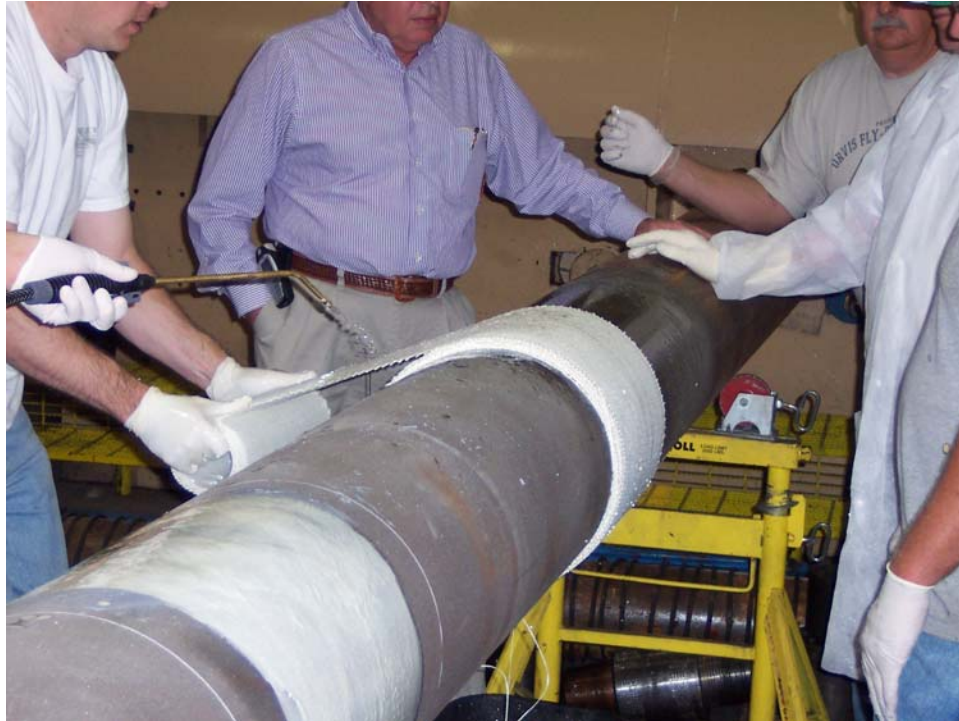
Figure 7 - Continued wrapping of Aqua Wrap in repairing damage

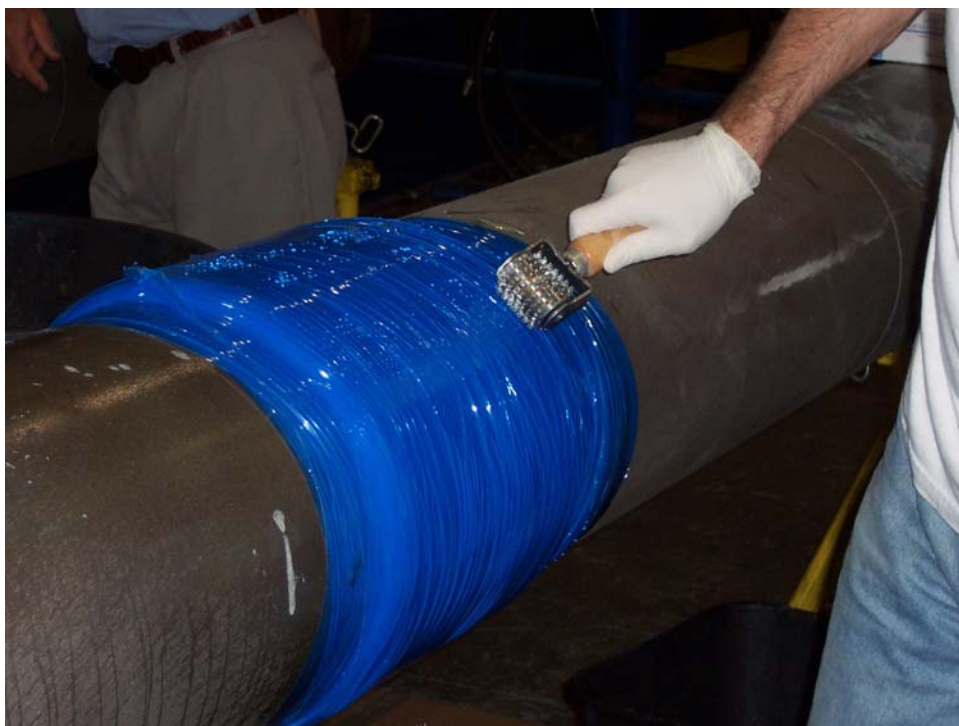
Figure 8 - Perforating plastic wrap to permit off-gassing during cure

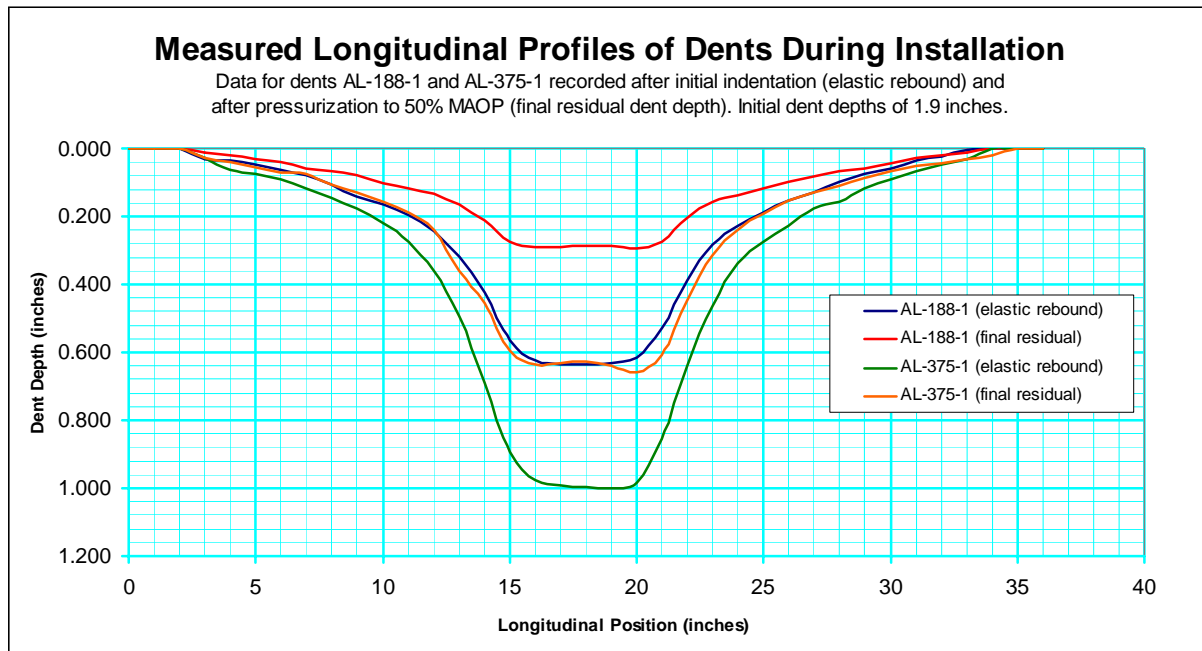
Figure 9 shows the longitudinal profile measurements for test samples AL-188-1 and AL-375-1. The measurements correspond to readings taken after initial indentation that capture the elastic rebound and measurements taken after pressurization to 50 percent MAOP. As with the data presented in **Table 1**, it is clear that a significant portion of the dent is removed by the application of internal pressure.

Figure 9 - Longitudinal profile measurements of exemplar dents

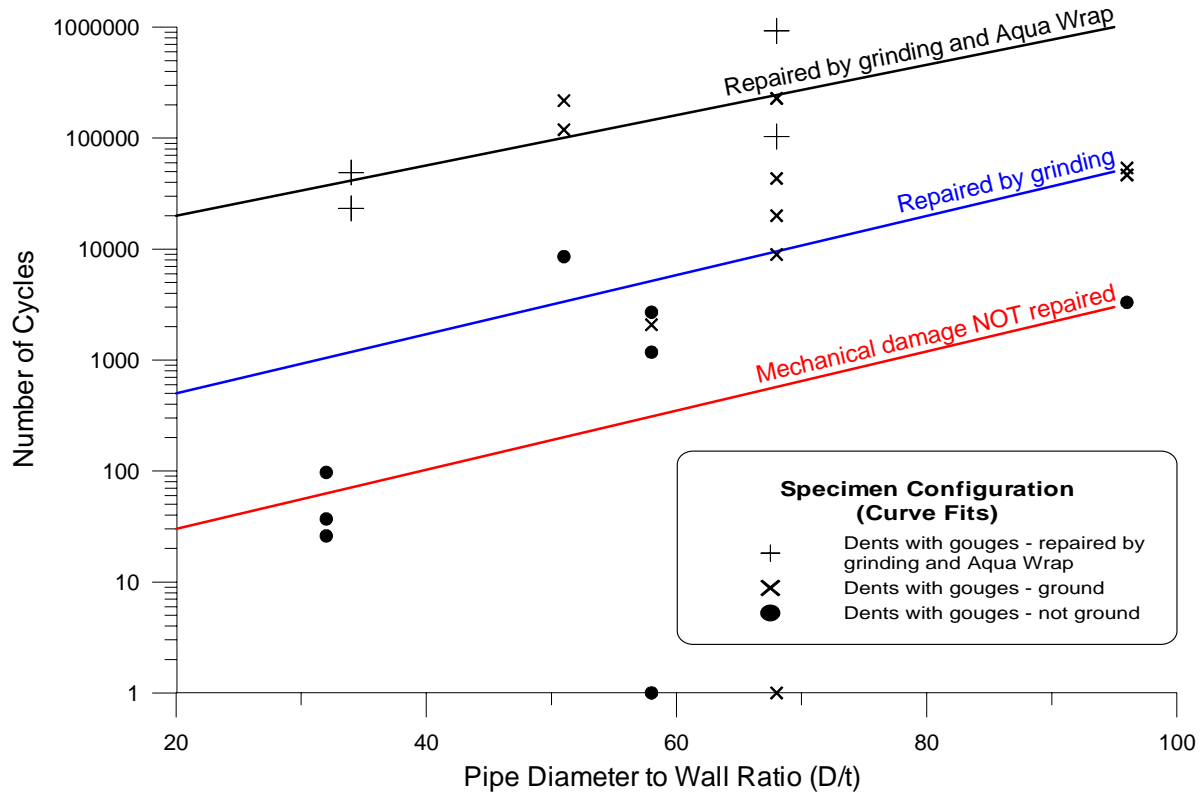
In addition to the tabulated data, fatigue results are presented in **Figure 10** that plots cycles to failure for the Aqua Wrap samples as well as data from previous research programs associated with mechanical damage. The predominant observation made in viewing this figure are the benefits derived in repair by grinding and using composite materials as compared to unrepaired mechanical damage. If one considers a pipe having a D/t ratio of 50 with a dent of 15 percent and a gouge of 15 percent, the fatigue life can be estimated from **Figure 10** as follows.

- An unrepaired defect has an approximate fatigue life of 100 cycles
- A defect that has been repaired by grinding has an approximate fatigue life of 1,000 cycles
- A defect that has been repaired by grinding and fitted with an Aqua Wrap composite sleeve has an approximate fatigue life of 100,000 cycles

This trend is consistent in what has been observed with other composite repair systems. The primary reason for the increase in fatigue life is that the composite material restrains the dent and prevents significant rerounding during the process of pressure cycling. It is the flexure of the dent that is the basis for the initiation and propagation of fatigue cracks in both mechanically-damaged pipes as well as pipes having plain dents (i.e. dents without gouges). Even though plain dents have fatigue lives that are significantly longer than pipes with mechanical damage (i.e. dents with gouges), the long-term failure of plain dents results from fatigue cracks that initiate in the dented region of the pipe.

Figure 10 - Fatigue test results for mechanically-damaged samples
