Analysis of Aquawrap[®] for use in Repairing Damaged Pipelines

**Environmental Exposure Conditions
Property Testing Procedures
Field Testing Evaluations**

Prepared By
Franz Worth, PE

September 28, 2005

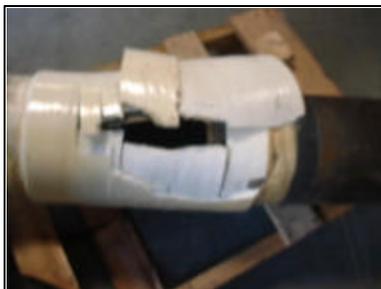
Figure 4.1
8.644" OD pipe with ruptured Aquawrap® at defect location.

1. 8.644" OD Pipe (Serial #967296) -
This test involved a pipe section with a machined defect measuring 8" long x 4" wide x .192" deep (59.6% wall loss). The pipe section was 60" long and closed at both ends with welded end-caps. Actual failure occurred within 3.5% of the calculated failure. This test provided very desirable results. Location L2.

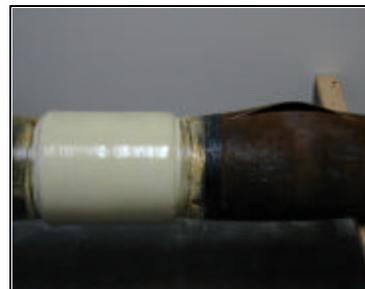
Figure 4.2
12.75" OD pipe with ruptured section adjacent to wrap.

3. 12.75" OD Pipe (Serial #958497) -
This section of pipe had a machined defect measuring 6" long x 1.47" wide x .125" deep (50% wall loss). The pipe section was 60" long and closed at both ends with welded end caps. The wrap installation was fairly conservative, as the goal was to burst the pipe outside the wrap section. Using our current Aquawrap® Composite Wrap Reinforcement Calculator, the 62 layers that were applied equates to inputs of 400 pounds per ply for the material, using a 0.67 design factor for the composite, and a safety factor of 1.25. Location L2.
